Asbestos Building Inspection Report

116 S. Topsail Dr.
Surf City, NC

AQA Project No.: 21-005-0123

Survey Date: January 23, 2021

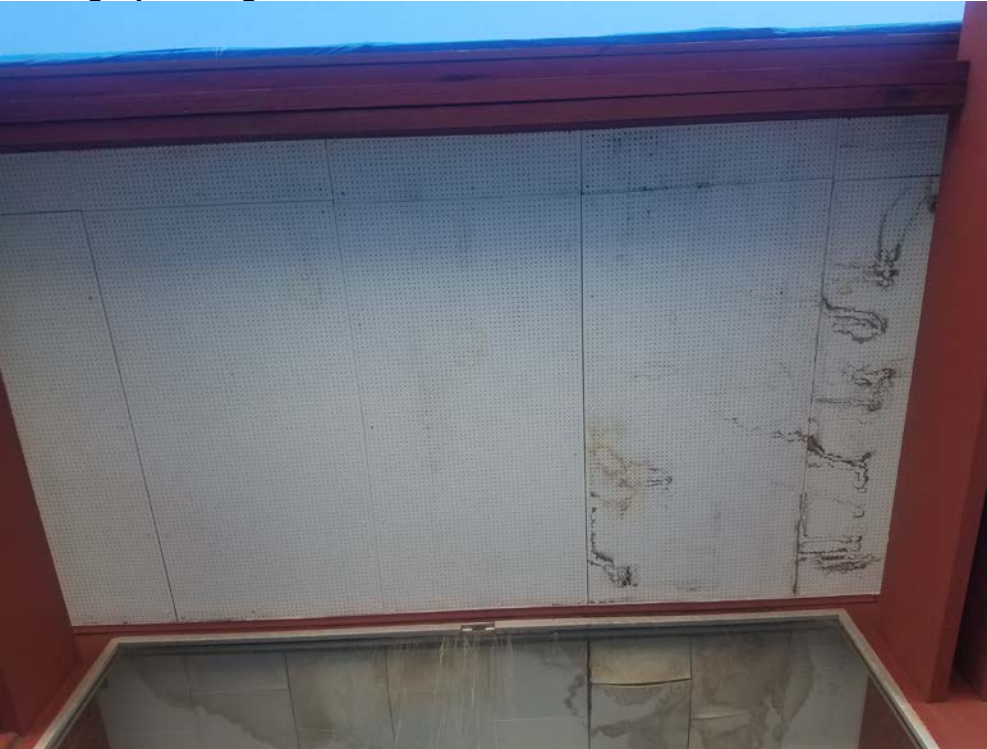
HM-05: Exterior Eaves, Transite Panel Boards, 15% Chrysotile. These materials cover an approx. 530 sq. ft. applied to the eaves. These materials can become friable with aggressive abatement techniques, and they must be removed by NC Accredited personnel prior to demolition of the structure.

HM-05: Exterior Eaves, Transite® Asbestos Paneling, 15% Chrysotile.

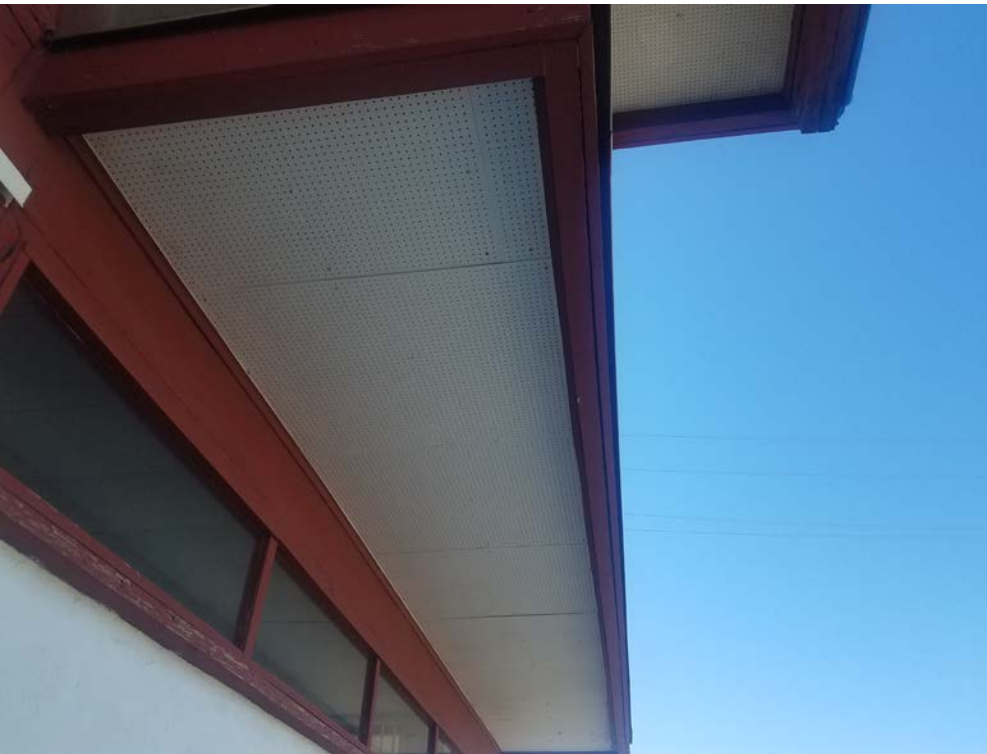
HM-05: Transite® Asbestos Paneling. See paneling applied to upper roof also.

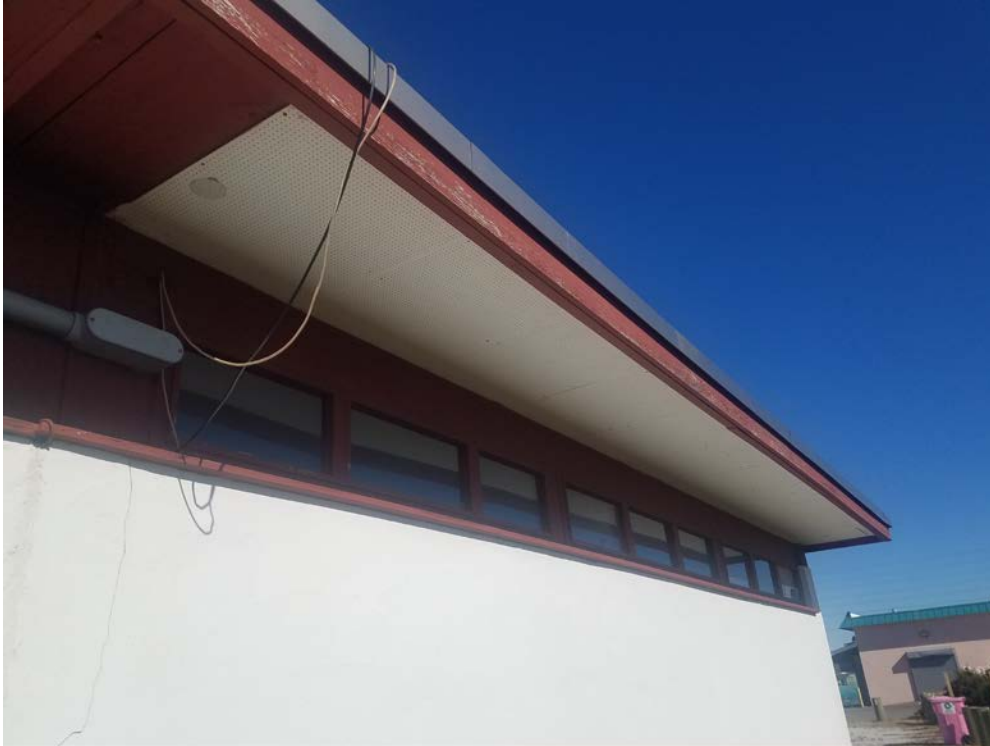
HM-05: Transite® paneling applied to eaves.

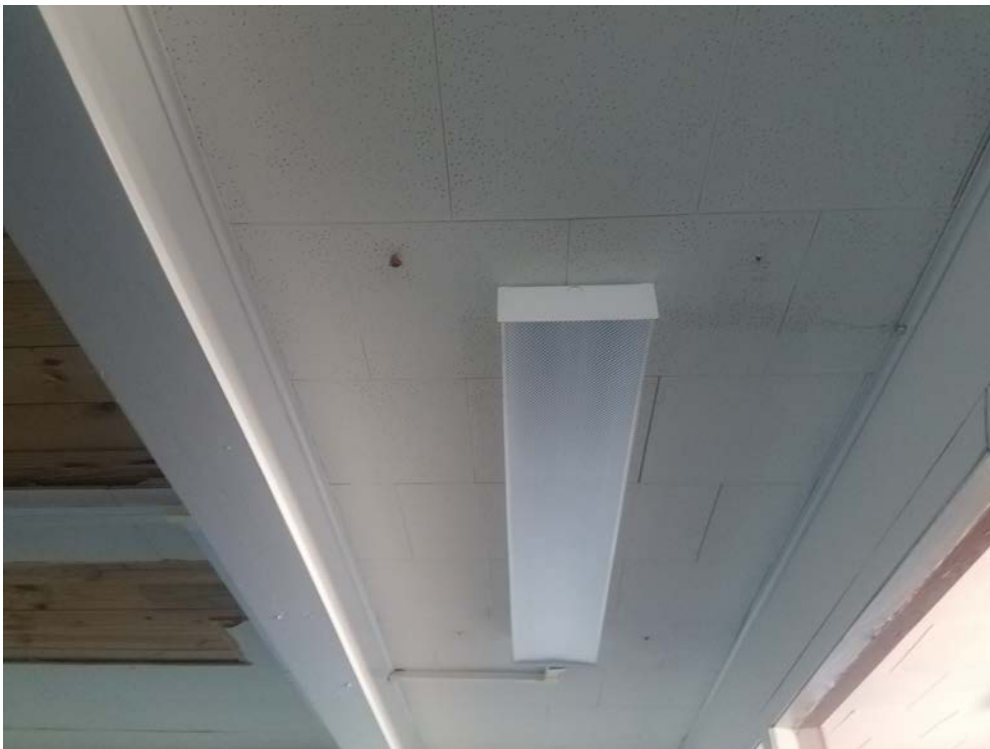
HM-01/HM-02: 12" Ceiling Tile applied in various room areas. Non-asbestos.

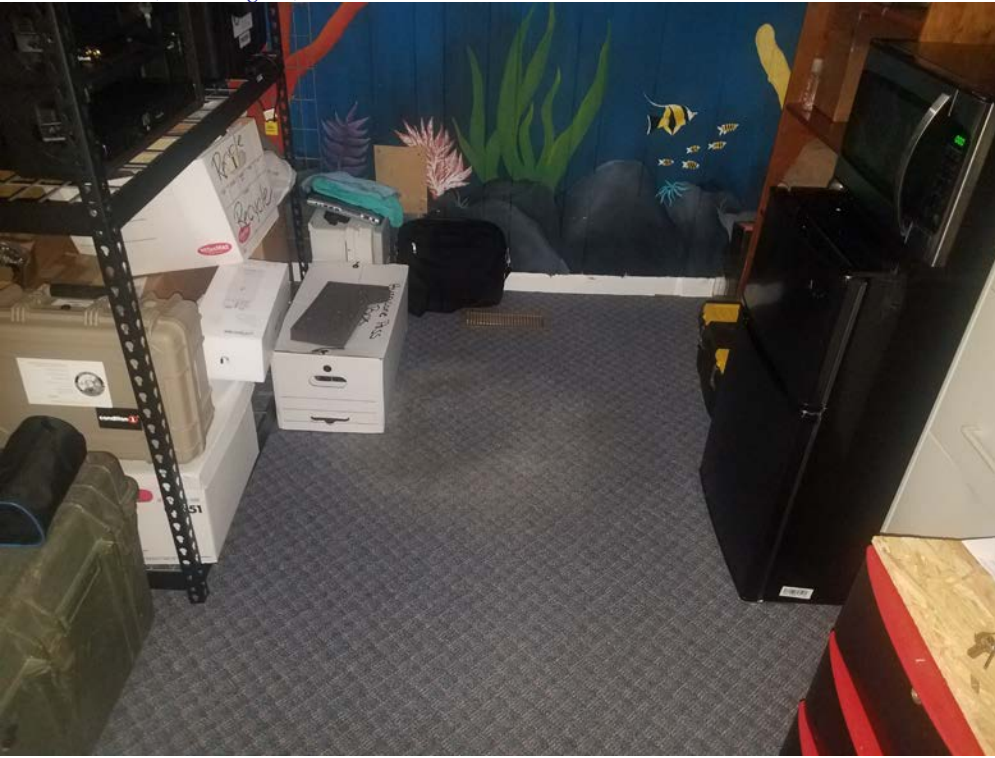
Carpet applied to concrete. Not a suspect asbestos containing material (ACM).

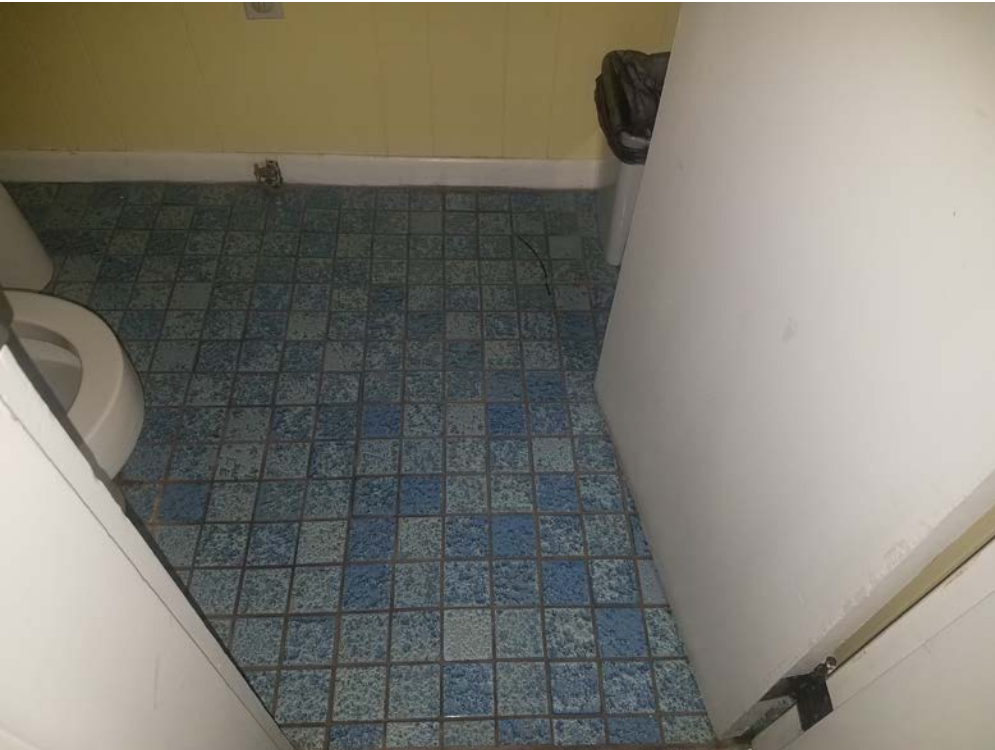
Ceramic Tile applied to concrete in the Bathroom. Not a suspect ACM.

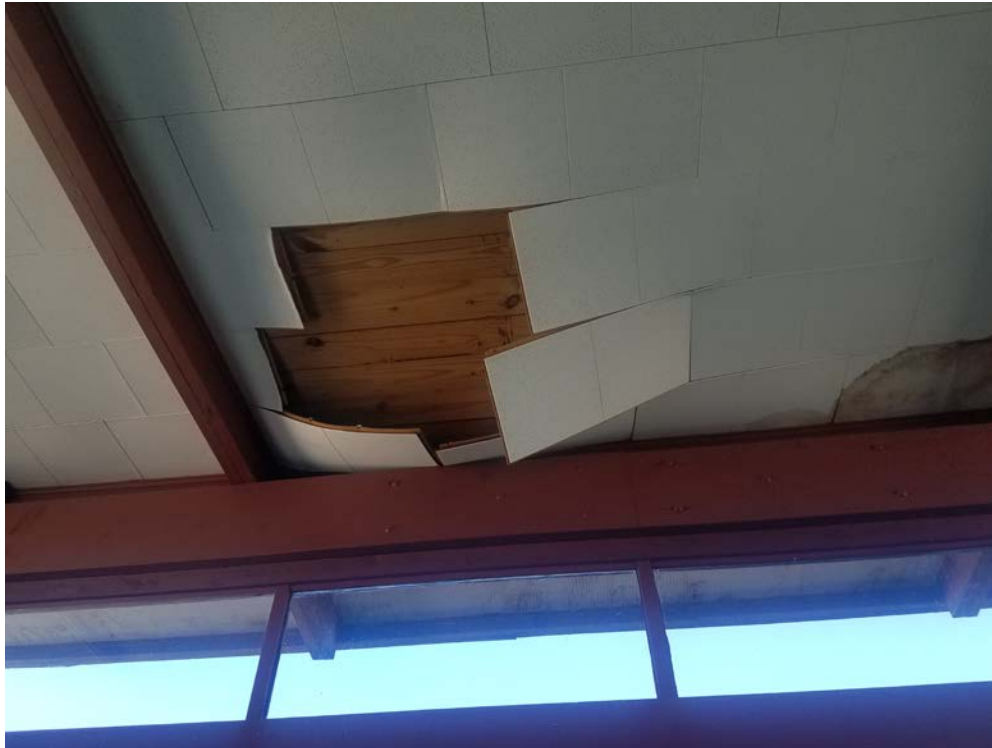
12" Ceiling Tile. Cellulose Backed. Not a suspect ACM.

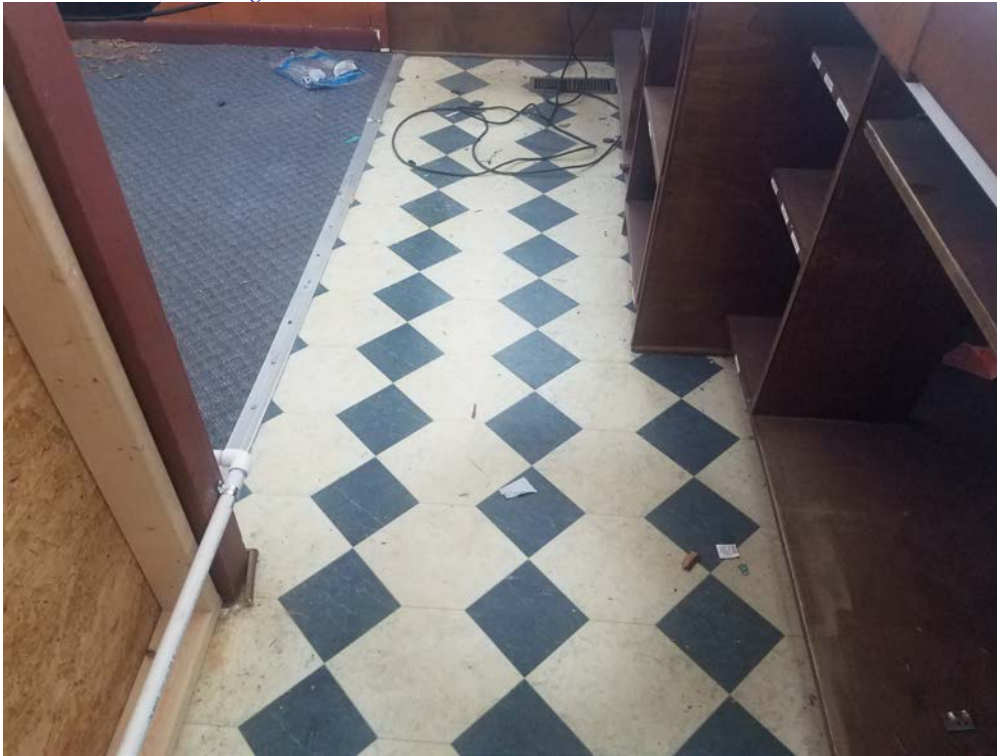
HM-06: Linoleum (Blue/Green/White). Applied in one additional room. Non-asbestos containing material.

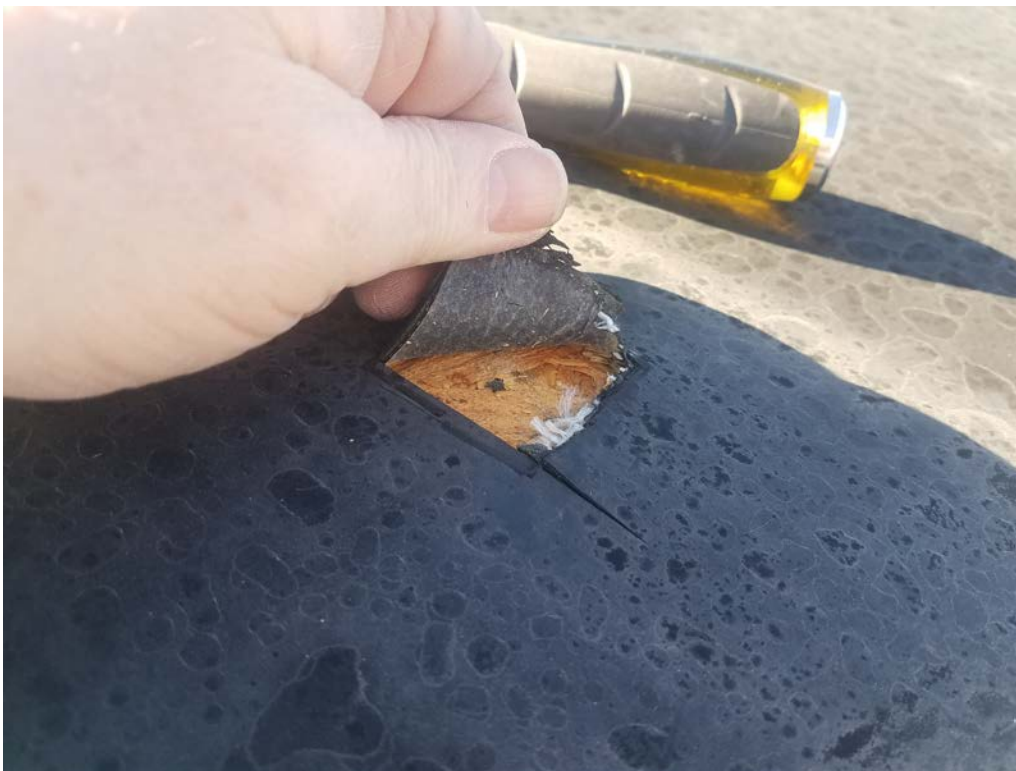
Rubberized Roof over Plywood. Not a Suspect ACM.
